Kalfarhagen Test Project 2014-2020

The building is an apartment complex in Kalfarveien in Bergen. The building consists of white painted concrete. The paint is a white acrylate paint from Beaker's paint. The east side of the building is close to green surroundings with lots of deciduous trees and forests. It is about 300m distance to E39 / E16 which is one of the busiest roads in Bergen. As the building is located in Norway, the building is exposed to a lot of acid rain which results in black gutter marks on the facade and provides an extra green basis for greenery.

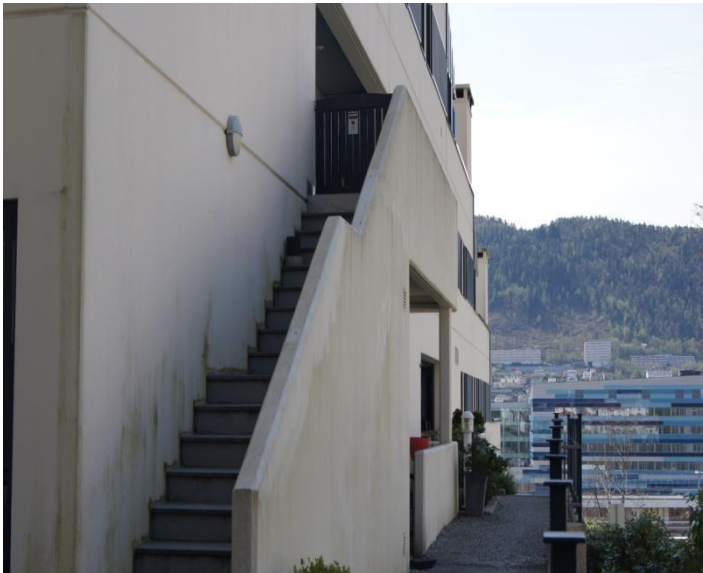
Problems with greenery and acid rain:

North side of the building.

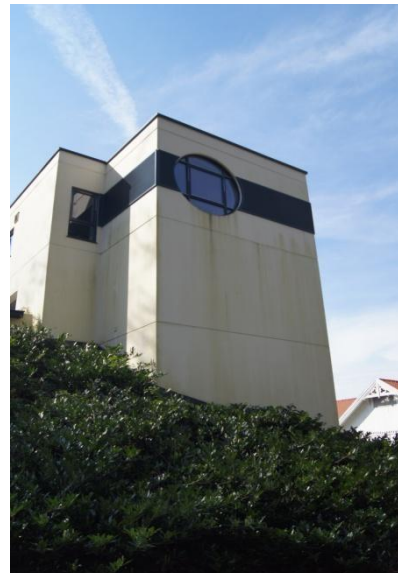
East side of the building.

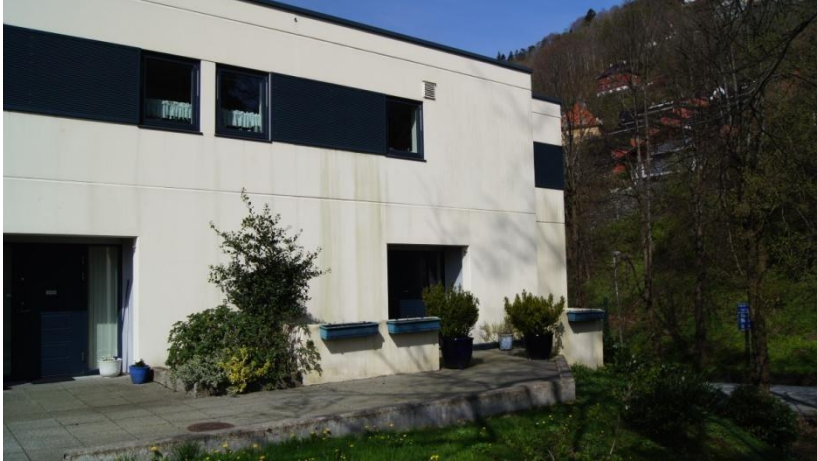
South side of the building.

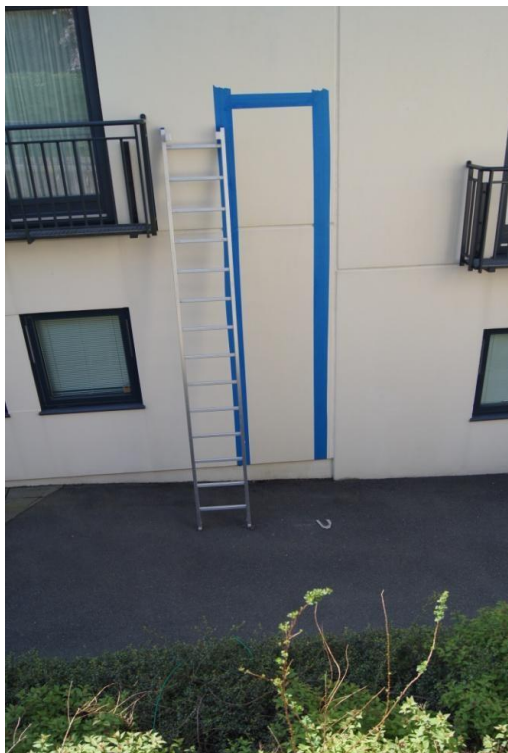
Test area masked, washed and ready for application.

The test area was treated with two coats of Pureti Base Coat and one coat of Pureti Clear. Pureti Clear is suitable for slightly porous surfaces such as painted surfaces, facade panels and glass. Between coats we had a drying time of 5 min.

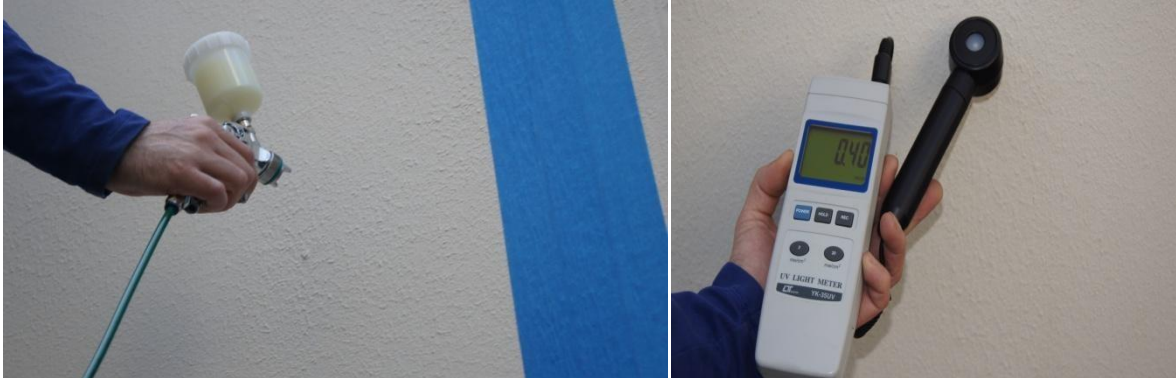
Application with compressed air and low pressure sprayer (30-40 psi). Brightness in the shade 0.40mw / cm²

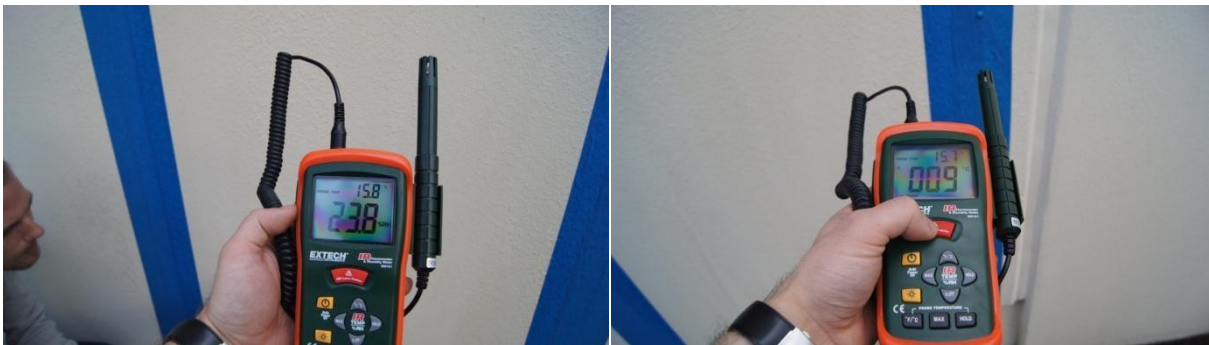
Relative humidity of 23.8%.

Air temperature 15.7 ° C and surface temp. at 9 ° C.

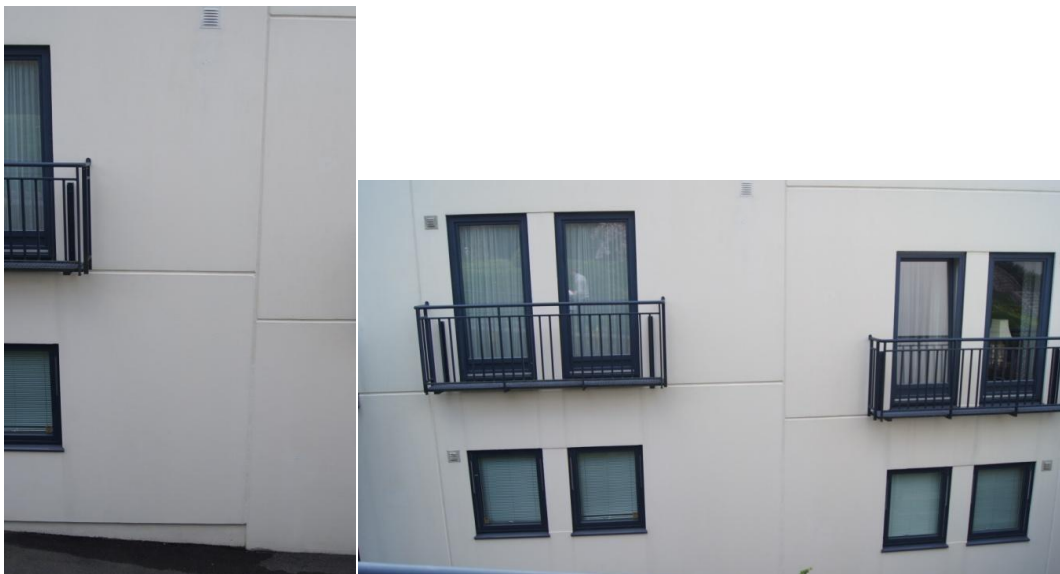
The test area has been completed (24.4.2014). After the treatment, we could not distinguish between the area that has been treated and the surrounding area.

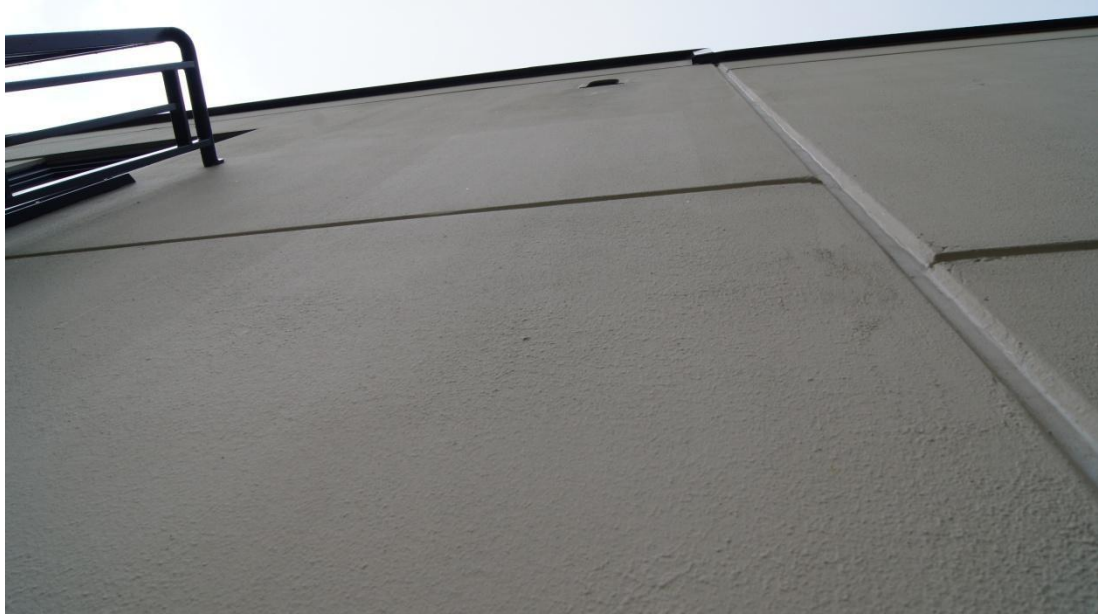
After 3 months we can start to see which area the test was performed on.

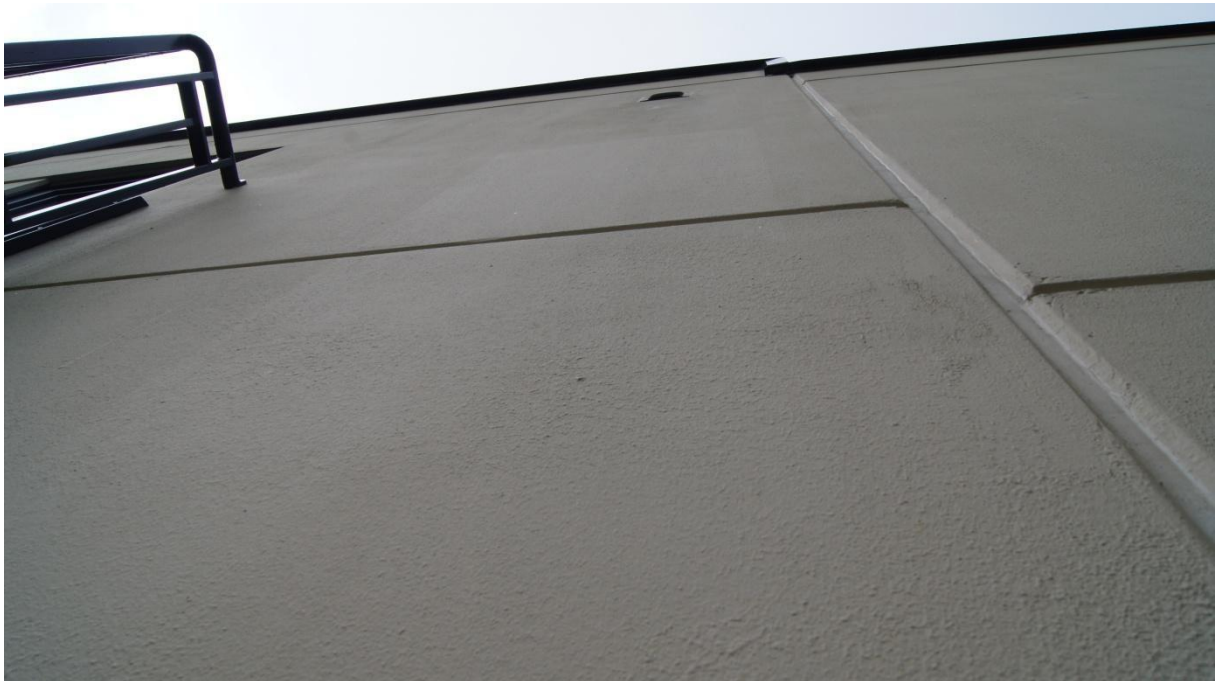
Test area after 4 months. It is now becoming more and more clear where the Pureti Clear treatment has been performed. We can clearly see the separation from the masking tape and otherwise on the wall around the test we see clear signs of gutter marks and what is the beginning of greenery.

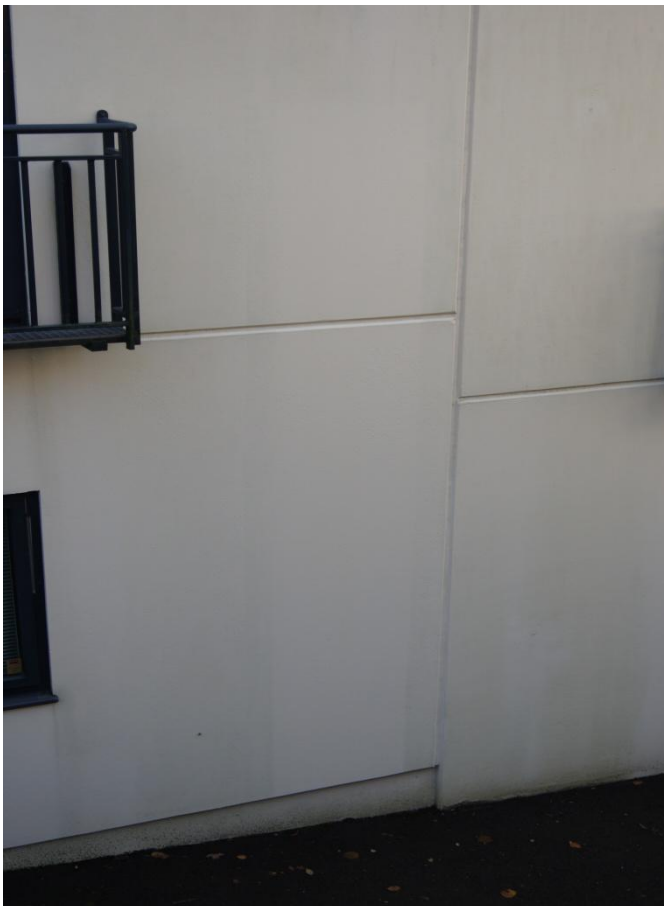
Test area after 5 months. We can now see very clearly where Pureti Clear is applied. The test area is completely clean while the surrounding area has absorbed color from acid rain and greenery.

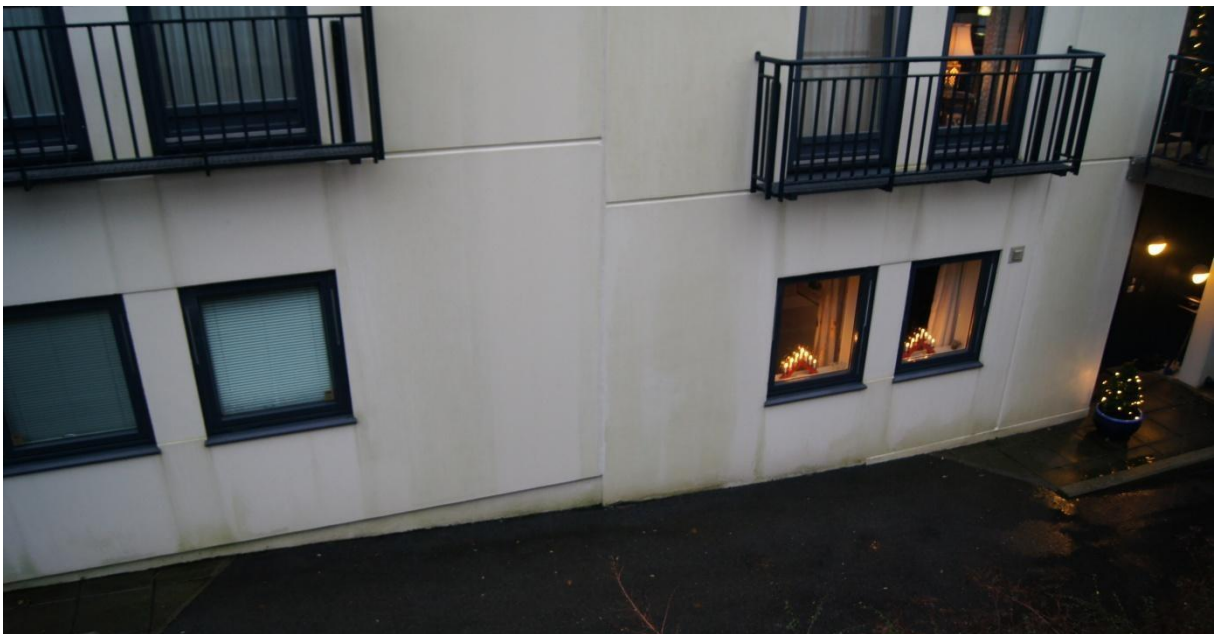
Test area after 6 months. The test area is still clean and nice, while the surrounding area has a clearer green color from greenery and acid rain.

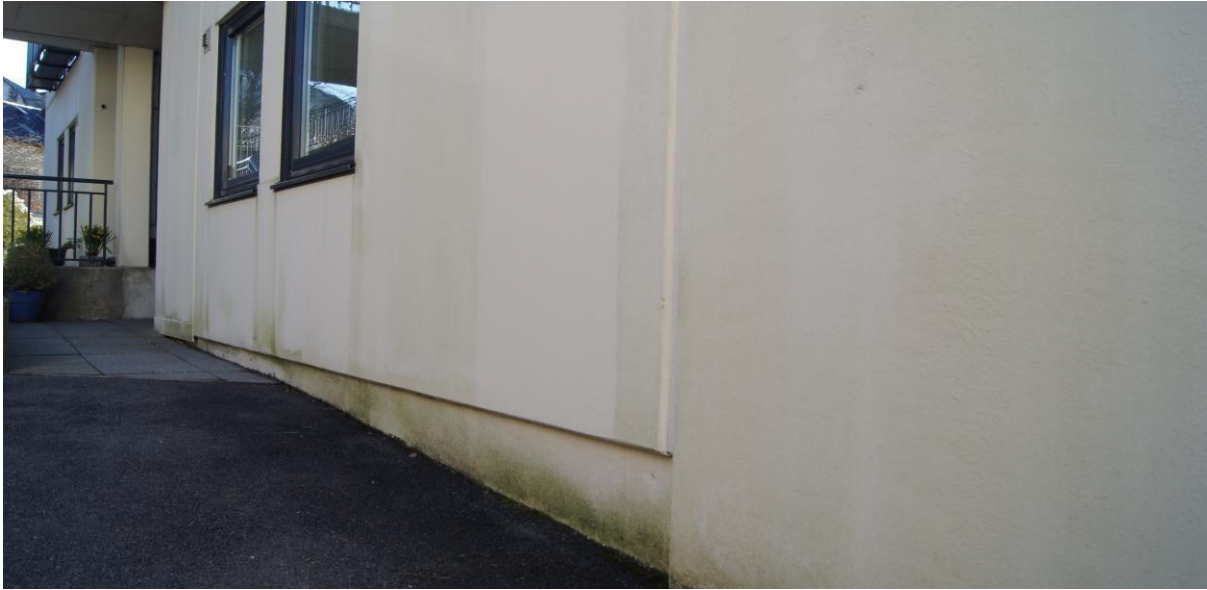
The test area after 11 months (21.3.2015). Now the test has been through the winter. The test area still looks just as clean and nice, while the surrounding area has become somewhat greener.

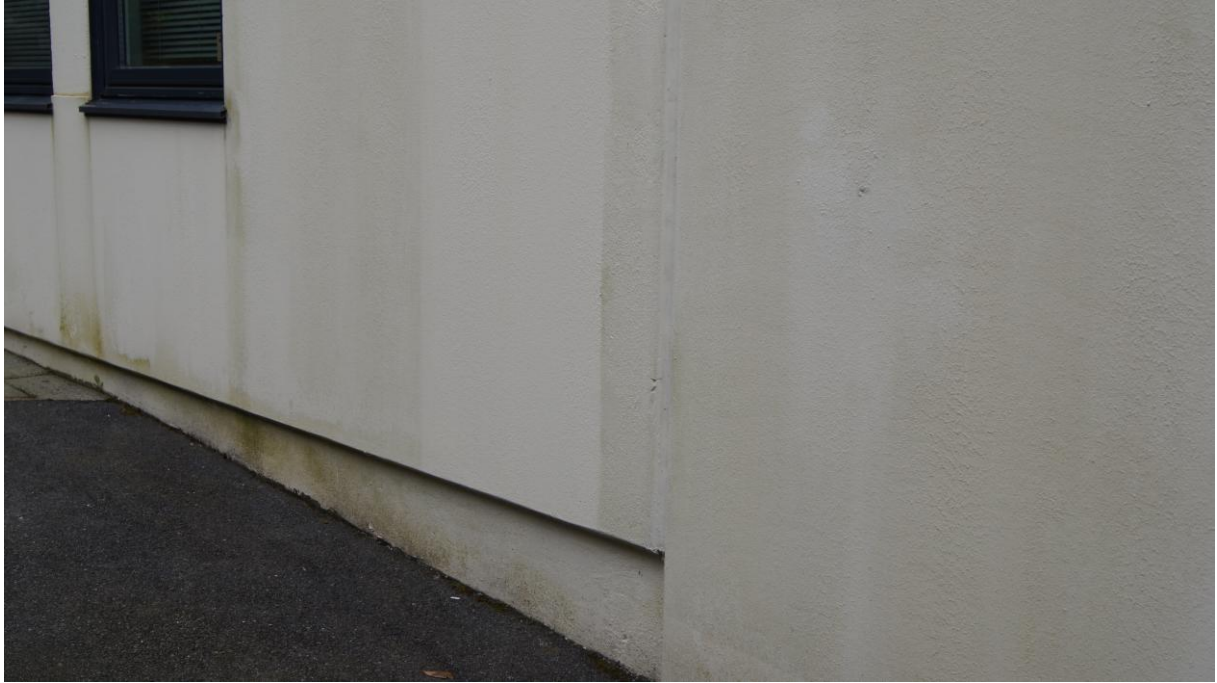
The test area after 16 months (31.8.2015). The test area still looks just as clean and neat. The board of Kalfarhagen co-owns are very satisfied with the test and has decided to clean their buildings and have all the facades treated with Pureti. The test has now been completed and all buildings were treated with Pureti.

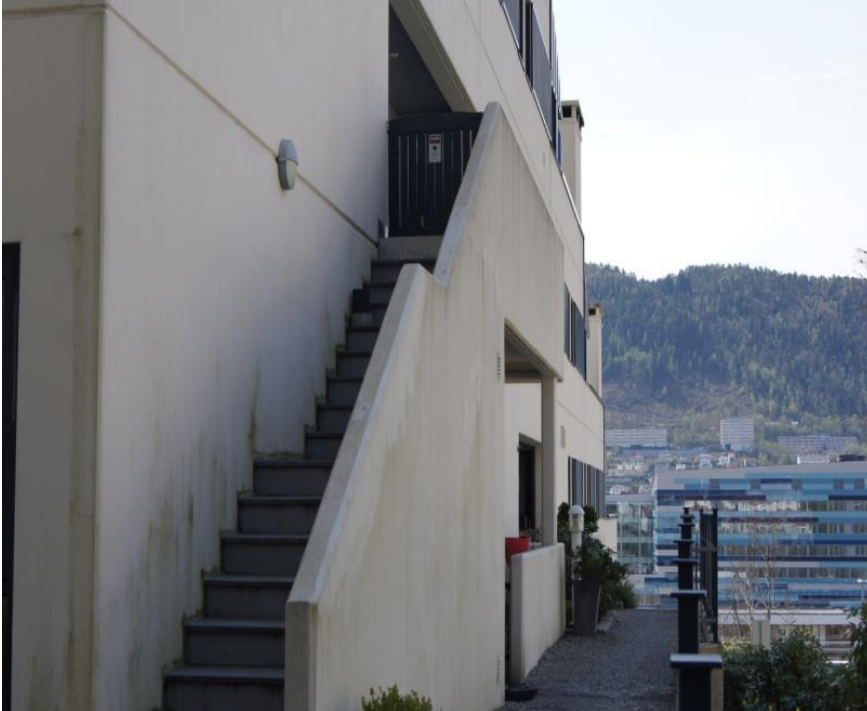
12 mnd. Etter normal nedvask (August 2015)

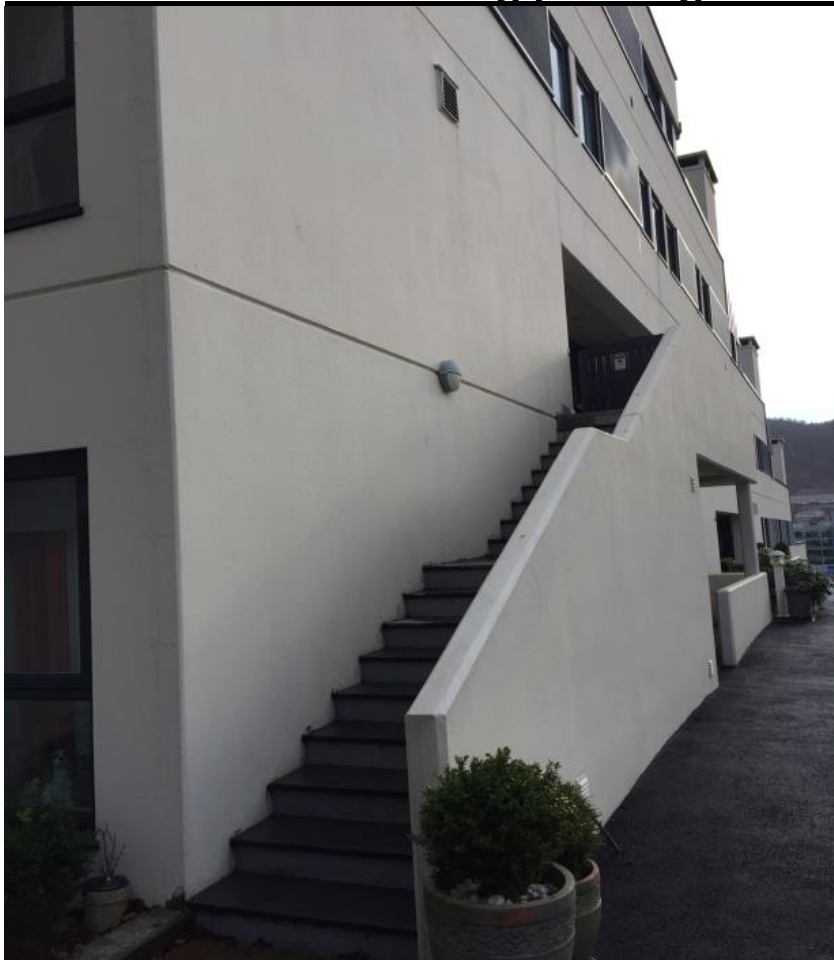
12 mnd. Etter nedvask og påføring av PURETi (August 2016)

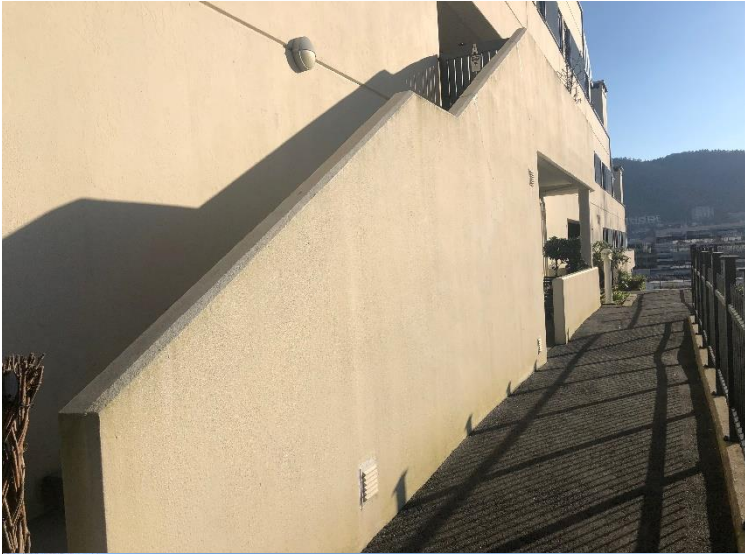
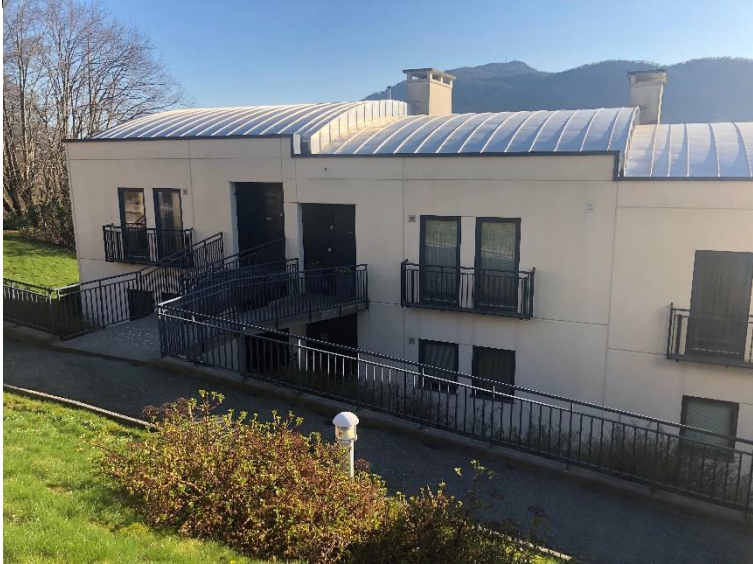
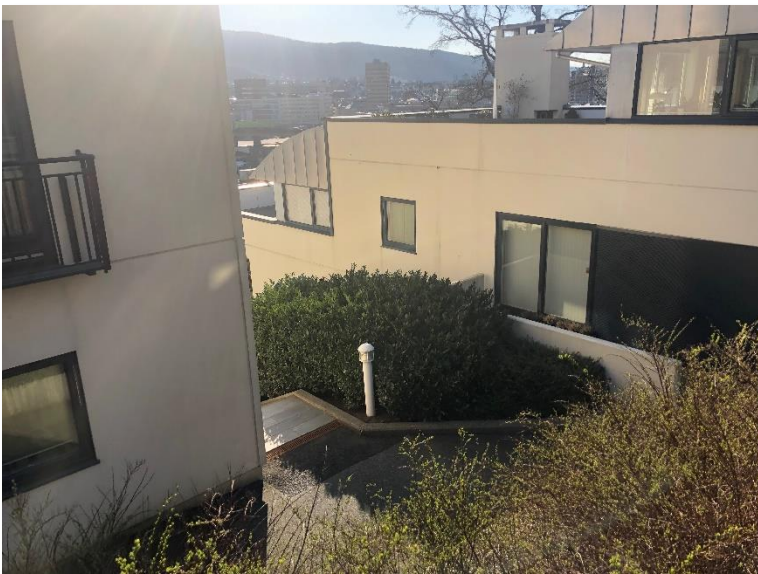
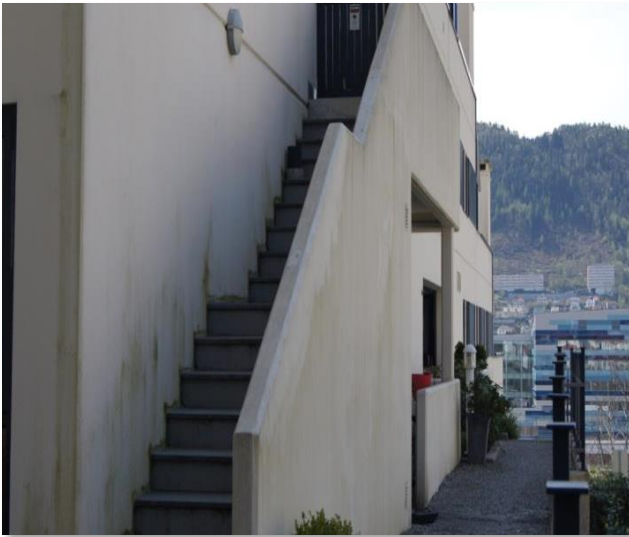
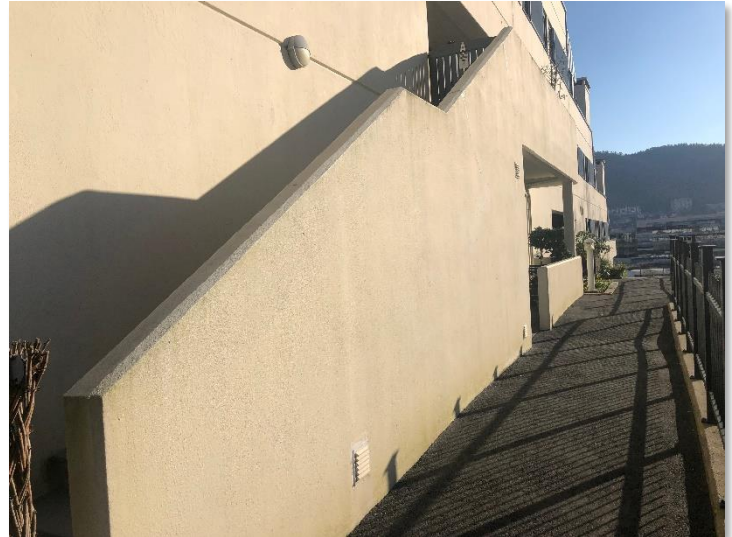
Project Kalfarhagen after five years

In August 2020, the PURETi-treated surfaces are cleaner than what the buildings were after 12 months of normal washing down.

After inspection in May 2020, the effect of PURETi is still very visible, it may seem that it seems even stronger now in the last year. The board of Sameiet Kalfarhagen is now considering whether to postpone the painting of the facades for another 3-4 years and that a new treatment with PURETi will be done then. The warranty period is 5 years, but the expected working time is up to 10 years and as it looks here, such a postponement of painting the buildings will seem beneficial.
